CALL THE HANDS

OCCASIONAL PAPER 32

HMAS *Voyager* (I) or What's in a Coat of Paint?

An Analysis of HMAS *Voyager*'s Unrecorded Paint Schemes February to April 1942

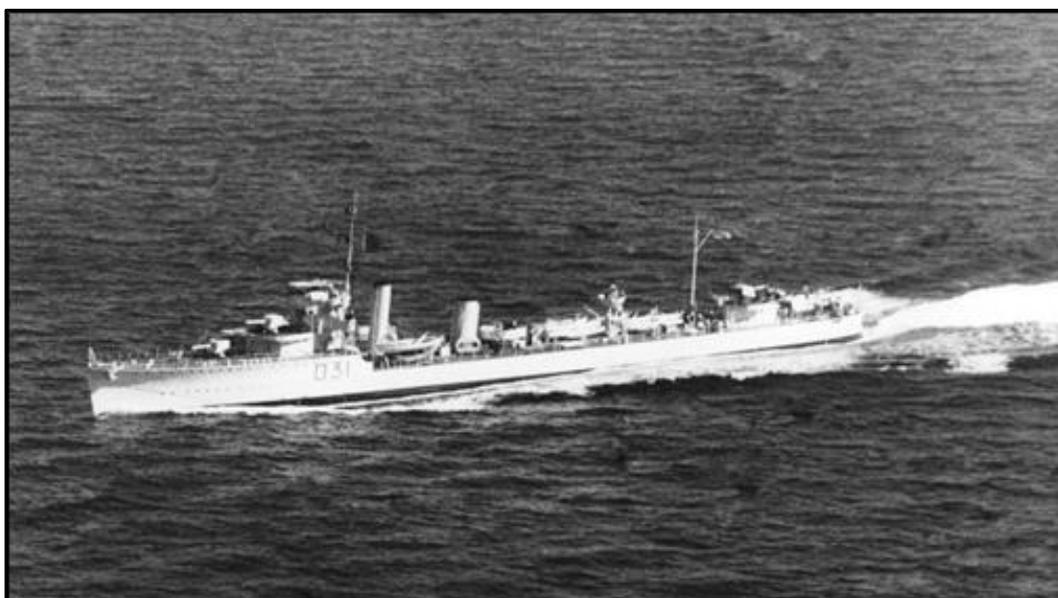
During WWII ships of the RAN were painted in a number of different colour schemes as these photos of *Voyager* illustrate and information on both peacetime and wartime camouflage paint schemes can be found in Appendix 1 and the accompanying papers. During the early years of the war, *Voyager* may have remained in peacetime livery without camouflage as this picture taken from the RAN ships histories page showing her in the Mediterranean dated 1940 suggests.

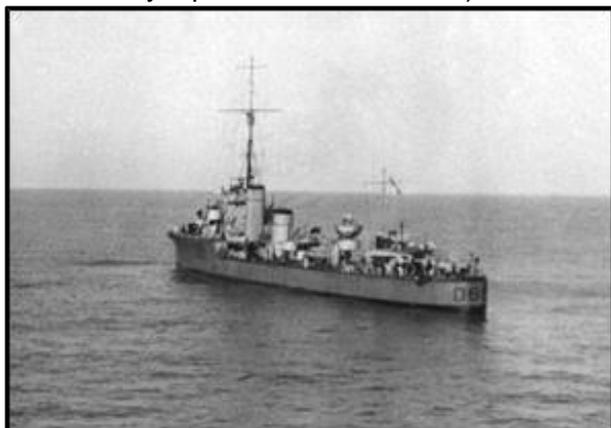
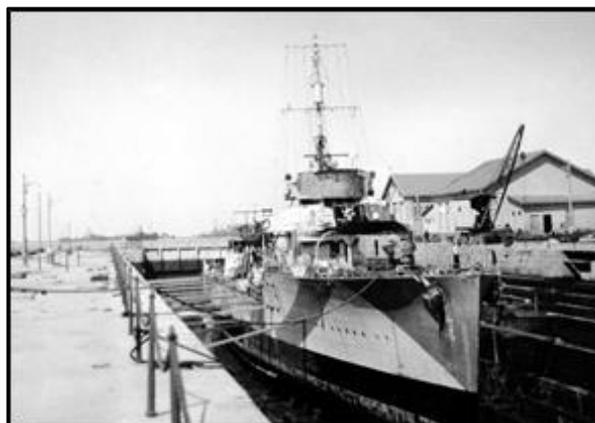
Brett Morrow, a member of NHS who is currently updating our records, studied RAN paint schemes and provided the information leading to the Appendix. He also provided these two photos, the first taken in early 1940 showing Vampire in a very different paint scheme, which would have been identical to *Voyager* for this time period. The 2-tone scheme shown is 507B for hull, and 507C for upperworks. (N.B. For ease of reference, the various shades used in ship's paint schemes are described by alpha-numerical codes)

And then *Voyager* in camouflage in dry dock in Alexandria in late 40, early 1941. In this later case, she wears the `D` flag superior in her pennant number. This was changed to the letter `I` sometime before mid-41, but it is unclear exactly when.

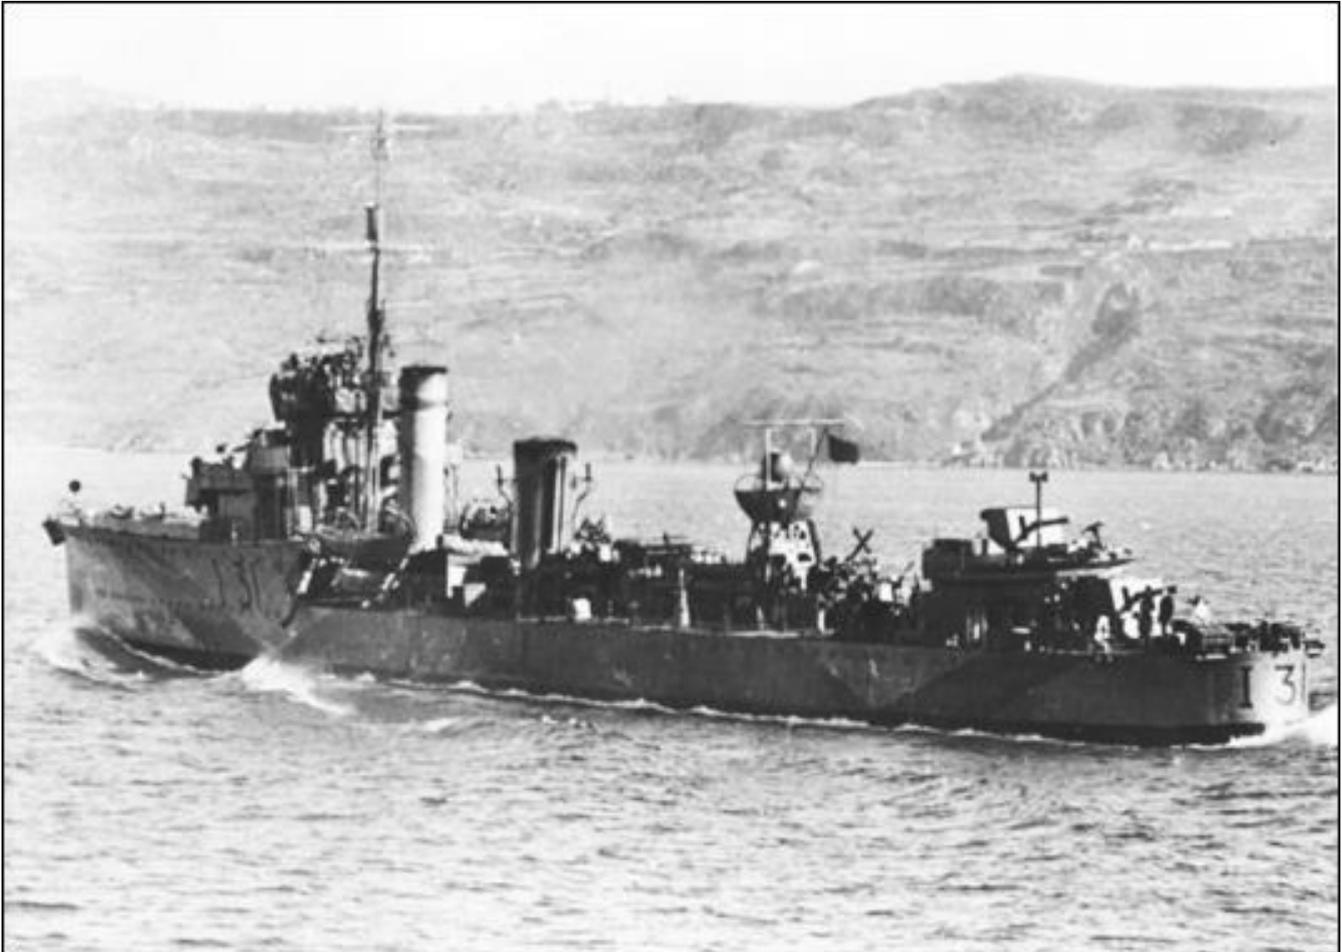
This photo of her with the pennant number I 31, was taken off Suda Bay, Crete during the evacuation of the island in May 1941.

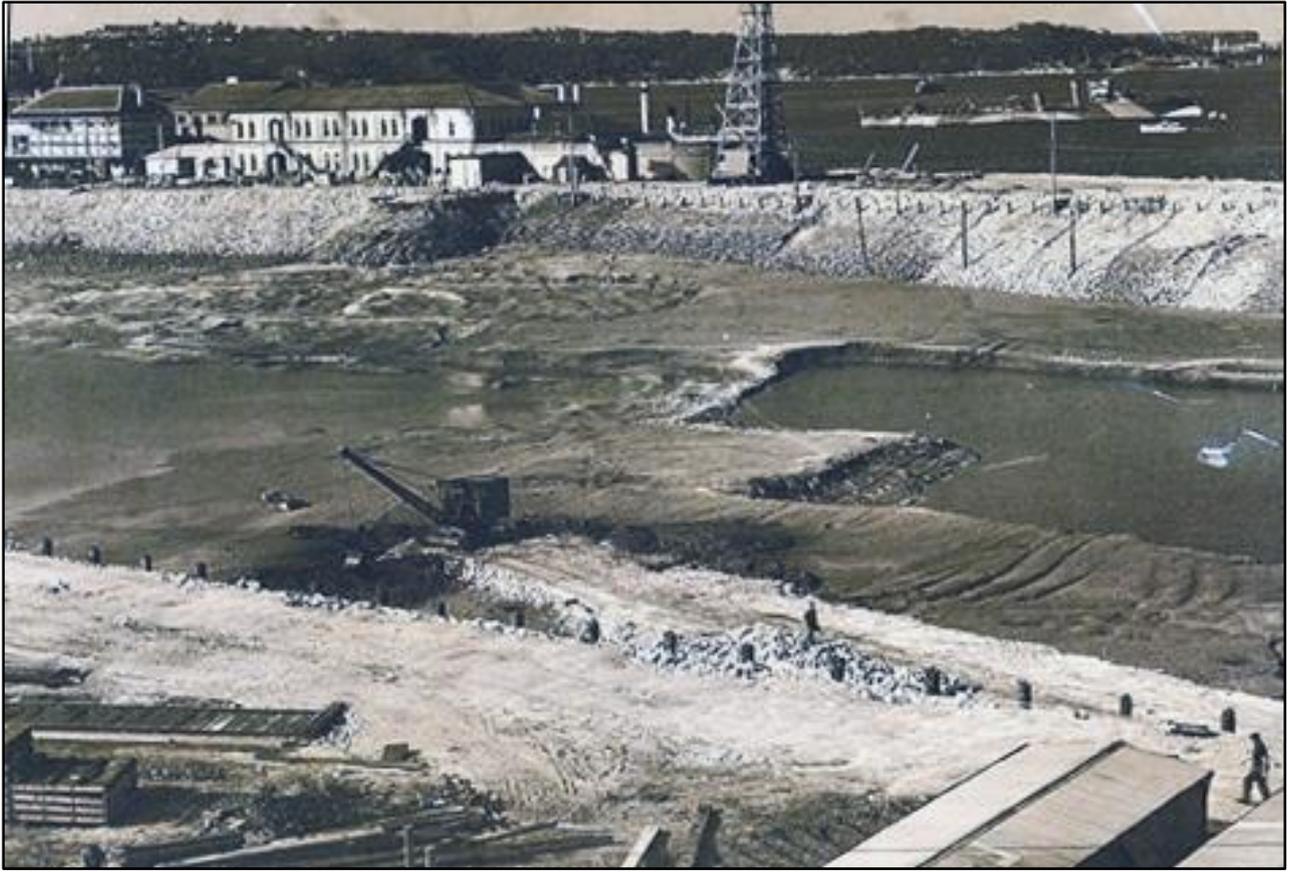
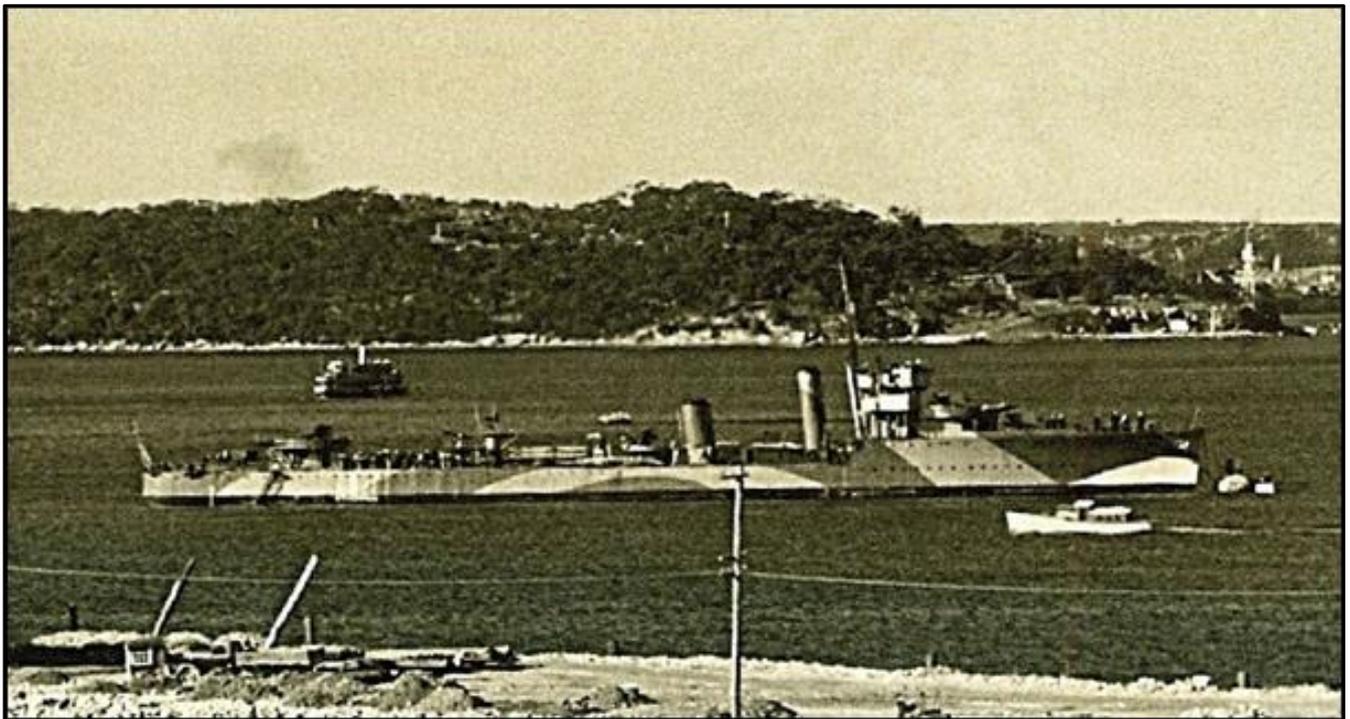
Very recently Brett has unearthed a very rare and historically significant find – the only known photos of the ship in a new camouflage. This picture of the construction of the Captain Cook Dock and the enlargements following show the starboard side of *Voyager* in the background, and the accompanying sketch drawn by naval photographer A.C. Green in 1942 illustrates this paint scheme. Note there are subtle differences to Green's original drawing and the actual scheme applied.

Our visual perception of tones can be governed by a number of factors, which include light, angles, glare, reflection and position of observation. The position of *Voyager* within the photo of Dry Dock reclamation shows she is anchored with bow pointing ESE approximately, the shadows thrown by objects ashore indicate a westerly sun between 1500 and 1600, for that time of year. Her starboard face is therefore receiving full sun not much above horizontal, but at a stern quarter aspect.

In referral to the large forward camouflage swatch, and taking into account the flare of the forecastle edge and curvature of her hull at that particular location, it cannot be stated categorically whether this particular swatch is the same colour as the trailing swatches of 507B, or is the darker colour of 507A. The same principle can be applied to the small triangle swatch on the bow peak.

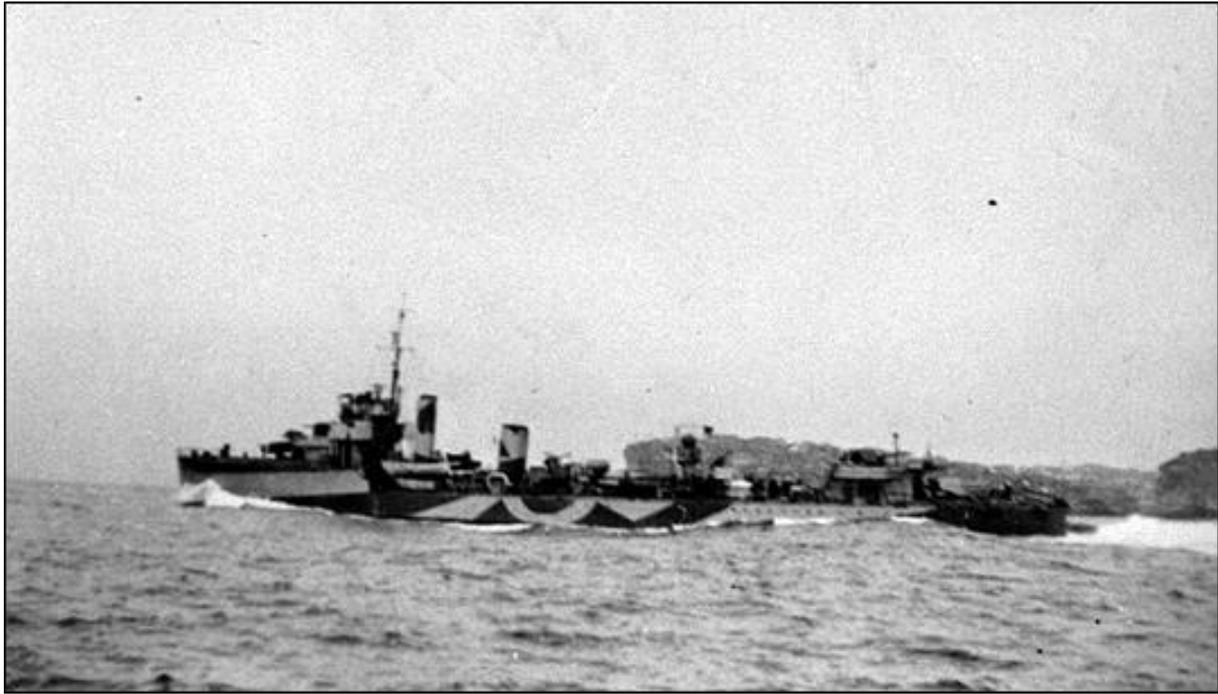
As *Voyager* exited Sydney Heads, the port side, different again, can clearly be seen. This unknown camouflage scheme for *Voyager* has gone un-noticed and unregistered for the past 76 years, and has also been held unknown and undetected until now, within NNSA records.

Further evidence has emerged that strongly suggests she may have been initially painted in the starboard scheme shown, identically on both sides, and subtle changes to the pattern continued after leaving refit in late Feb/early March 42. At this time *Voyager* appears to have been used as a pattern for camouflage tests. The port pattern shown has probably been applied over the initial scheme sometime early April as part of the test programme, and unless further evidence appears it is unknown if her starboard side followed suit.

The colours of both schemes shown are likely to have been made up of 507A, 507B and 507C, but the possibility also exists that it may only have 2 colours contained of 507B and C. A white false bow wave was applied to both schemes. By early May 42 thru to Sept 42 she had been repainted in Home Fleet Dark grey 507A overall.

The same can be said for the new port pattern, the image is of rather low quality, and we do not know if it was full sun or overcast at the time the photo was taken. The midship section rise to forecastle level at the bridge superstructure, shows what could be a darker patch, compared to the other dark patterns, but this could also be a photo imperfection. Therefore, the same approach is made to the

port scheme colours and left to the reader's interpretation. We have no official records and the darker swatches could all be 507A, 507B or a combination of both, with the overall lighter colour being 507C. We do not know if the starboard pattern was repainted again the same as port, but my opinion is that it was left intact.

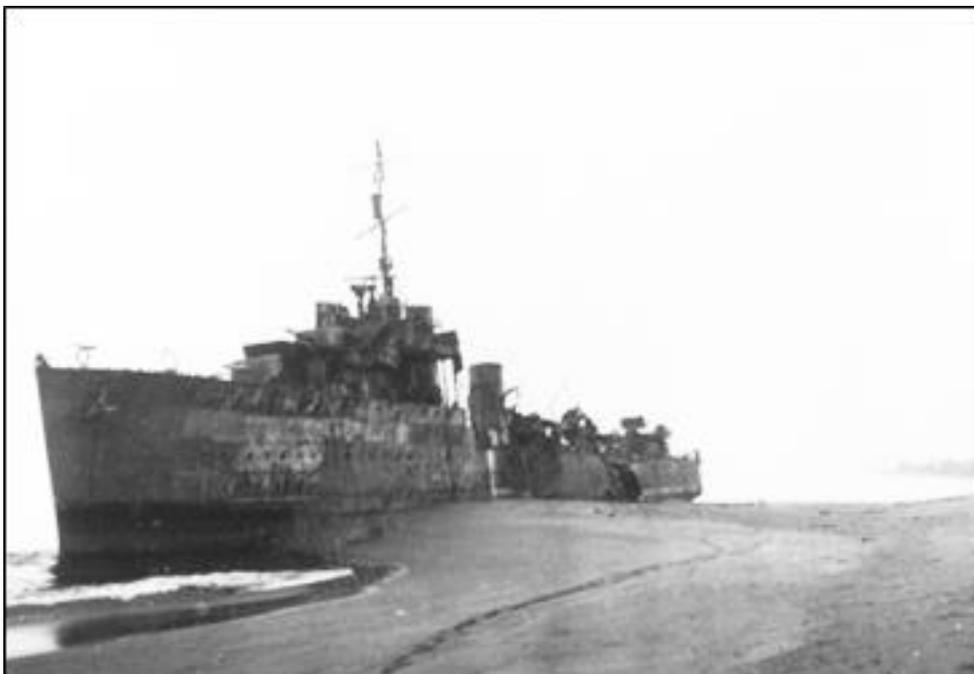
It seems that *Voyager* remained in this guise until she ran aground on the beach in Betano Bay during operations on 23 September 1942.
